## ALERT SERVICE BULLETIN

**505-23-35**

**MODEL AFFECTED:** 505

**SUBJECT:** OIL COOLER FAN ASSEMBLY HOUSING BRACKET, INSPECTION AND MODIFICATION OF.

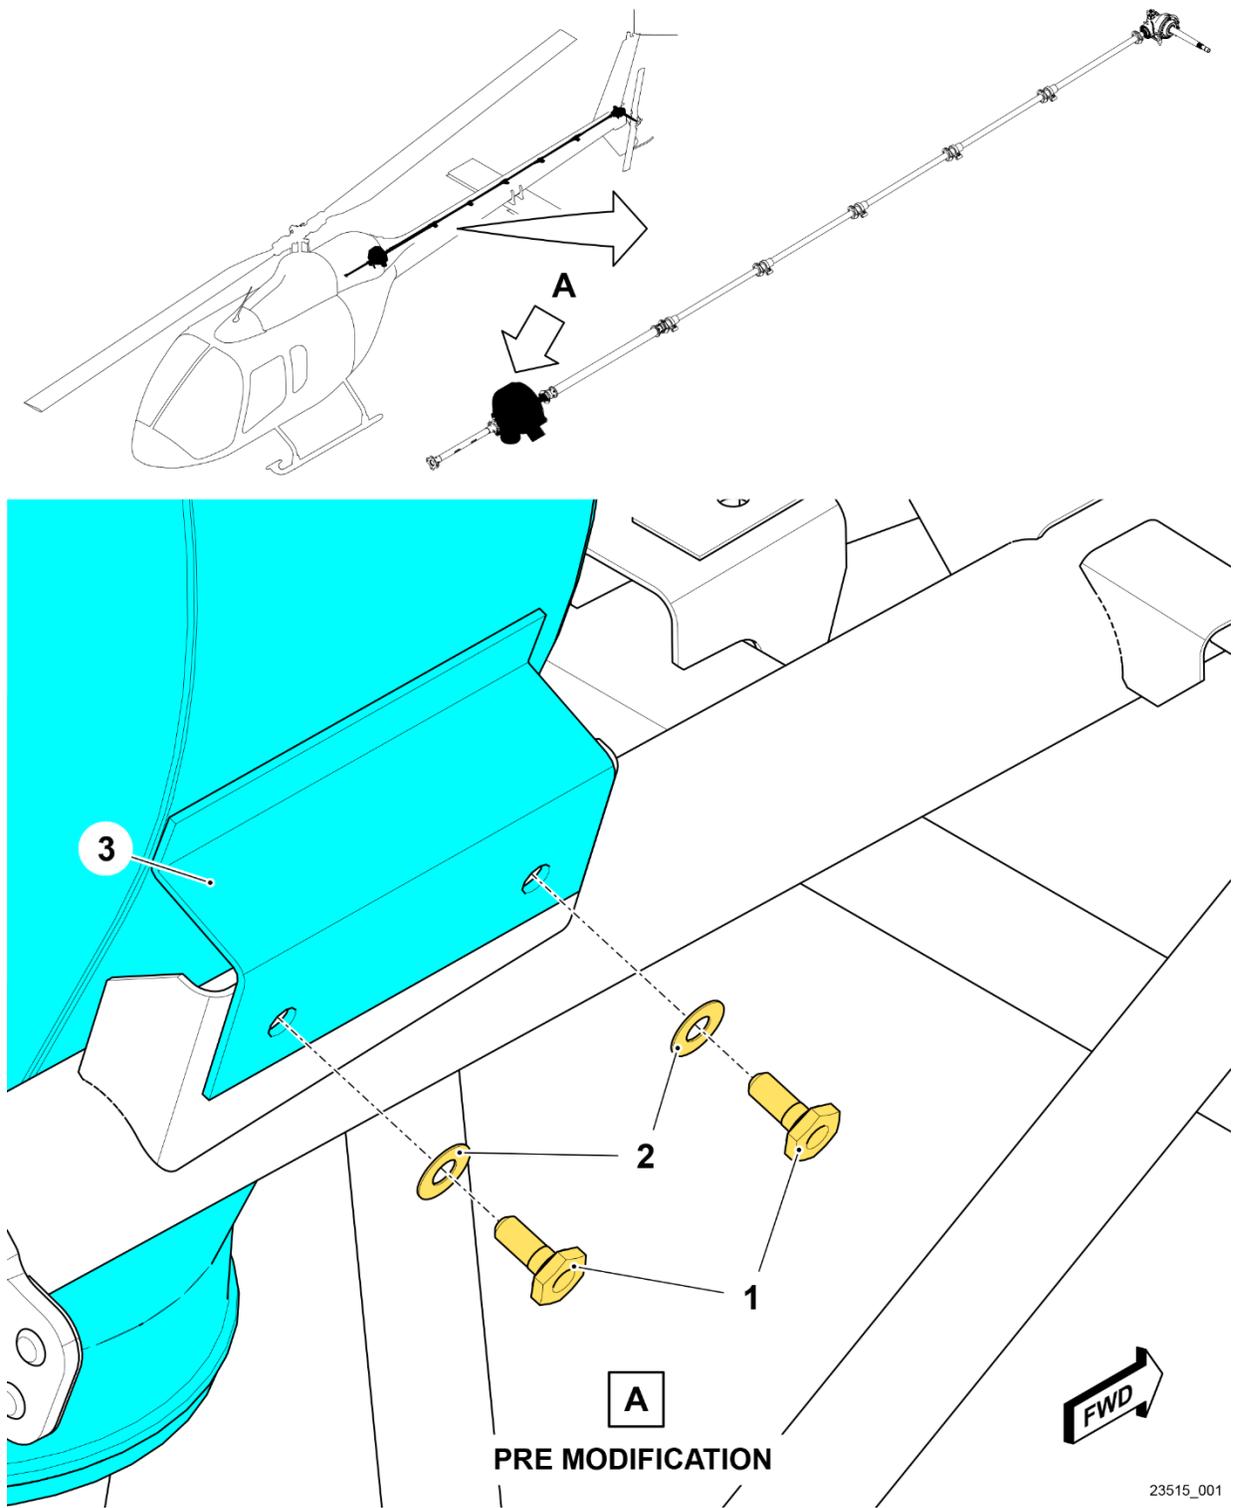
**Figure 1 – Oil Cooler Blower Housing Installation (sheet 1 of 4)**

Bell was informed that an oil cooler fan assembly housing mounting bracket was found cracked. The initial design was a “Z” shaped bracket that was welded to the housing and then bolted to a bracket on the truss. To improve the fit and installation, Bell improved the design to a slotted bolted bracket at the housing and the truss. **PART I** of this Alert Service Bulletin requires a one-time inspection of right bracket for cracks. If found cracked, modification of the installation must be accomplished prior to next flight. If the bracket is not cracked, modification of the bracket is to be accomplished within the compliance period of **PART II**. **PART II** of this bulletin provides the instructions how to modify the bracket.

1. Prepare the helicopter for maintenance.
2. Remove the exhaust fairing (444AT) ([DMC-505-A-53-40-05-00A-520A-A](#)).
3. Using a 10X magnifying glass and bright light, inspect the right bracket (3, Figure 1, sheet 1 of 4) of the oil cooler blower housing for cracks.
  - a. If a crack is found, perform **PART II** of this bulletin prior to next flight.
  - b. If no cracks are found, perform **PART II** of this bulletin within 50 flight hours or 90 days, whichever occurs first, following the accomplishment of **PART I**. Go to step 4.

4. Remove bolts (1, Figure 1, sheet 1 of 4) and washers (2). Measure gap between bracket (3, Figure 1, sheet 1 of 4) and truss bracket (10, Figure 1, sheet 3 of 4).
  - a. If gap is less than 0.016 inch (0.406 mm), go to step 5.
  - b. If gap is 0.016 to 0.050 inch (0.406 to 1.27 mm), shim the gap using NAS1149D0316J and/or NAS1149D0332J washers. Apply sealant (C-308) on faying surfaces of washers prior to installation. Go to step 5.
  - c. If gap is greater than 0.050 inch (1.27 mm), perform **PART II** of this bulletin prior to next flight.
5. Apply corrosion preventive compound (C-104) to the shank of the bolts (1).
